## **Chelsea Tank Farm Tank 708 Release**

**July 2026 Virtual  
Public Meeting**

# **Summary of Key Elements – Incident Background, Investigation, & Public Involvement**

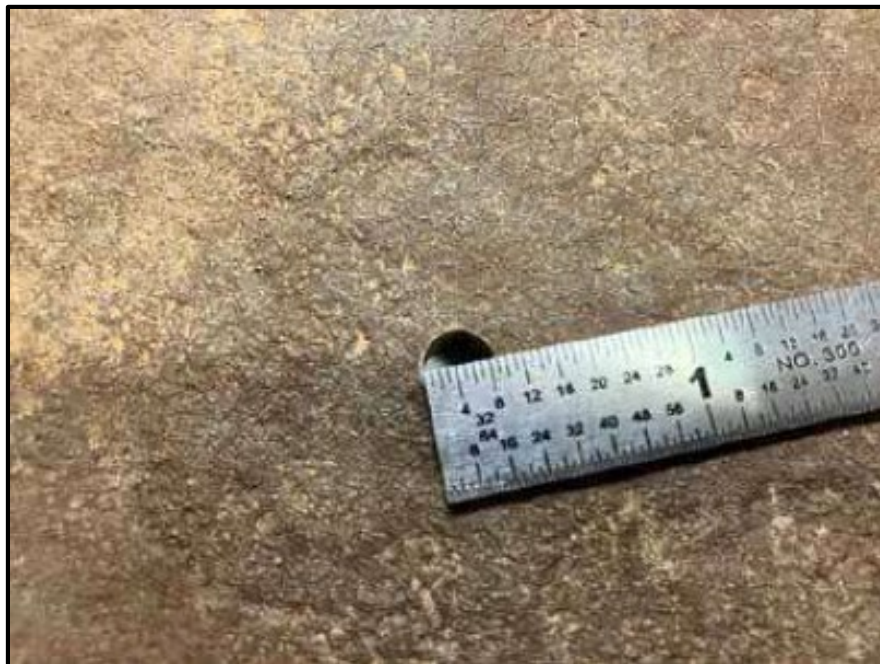
## Source & Reduced Release Volume

- 1/4 inch man-made hole found in the floor of Tank 708
- Revised estimated maximum release volume reduced to 7,779 barrels

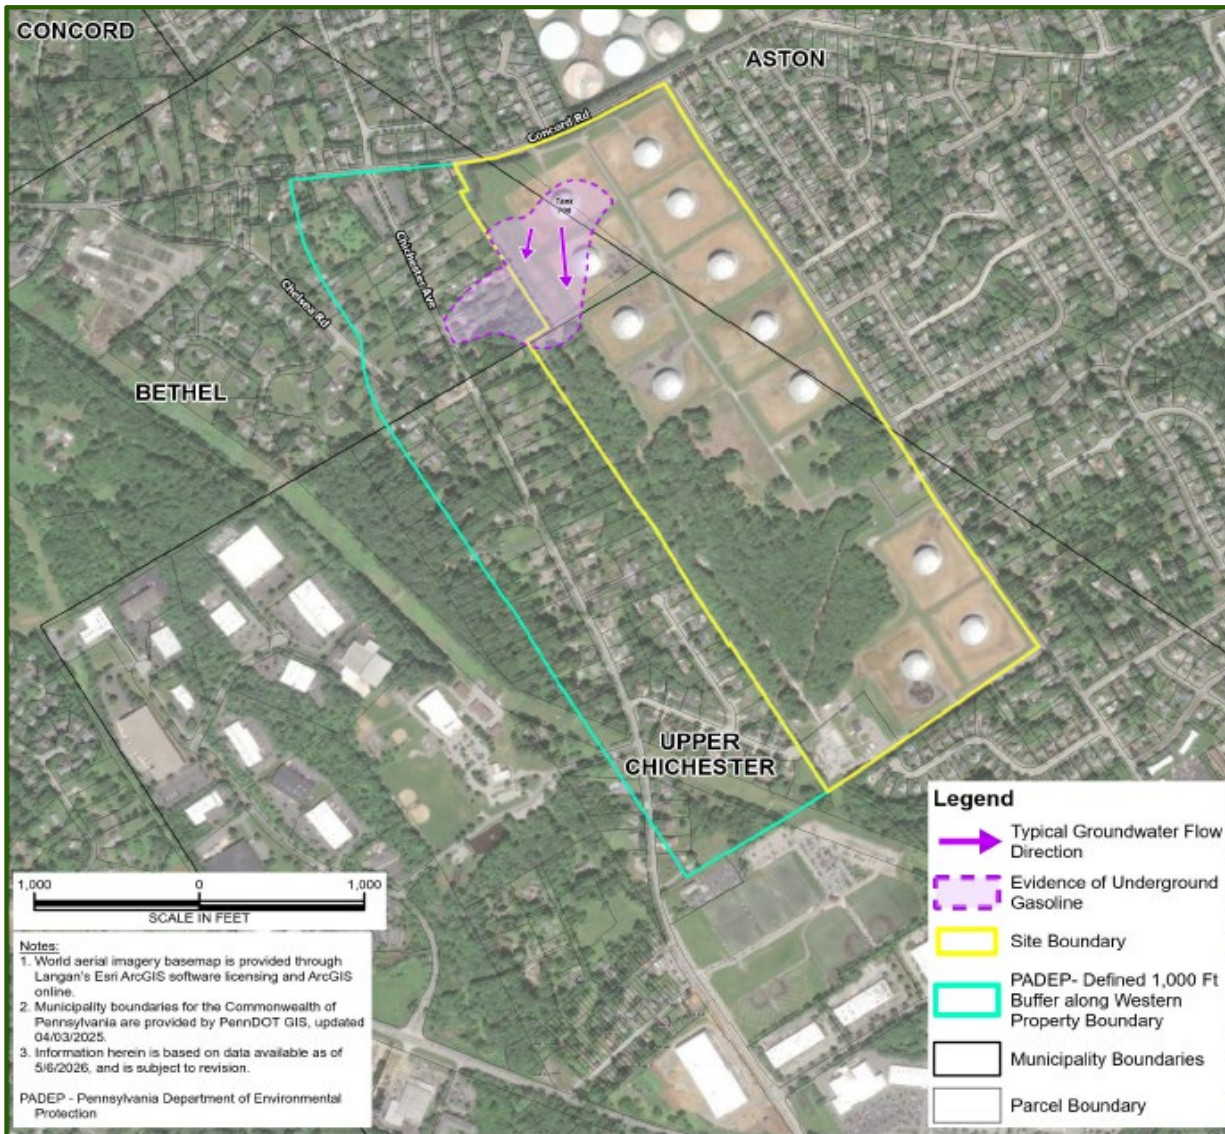
# Delineation

- MIPC has fully delineated onsite impact.
- MIPC has largely delineated the offsite impact.
- Current data shows that there are no offsite impacts to the north, east, south, and most of the west.
- Affected residents reside within the shaded area of the map adjacent to Chichester Ave. in Bethel Township.

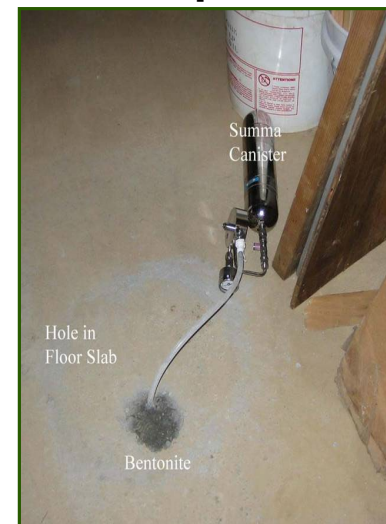
## Sub-Slab Vapor Sampling

- Initial residential vapor intrusion (“VI”) assessment in January found no exceedances
- Follow-up offsite VI assessments in April and May:
  - MIPC sampled sub-slab air at 12 nearest properties where access was granted
  - 9 of the 12 properties = no exceedances
  - Other 3 properties = VI mitigation systems installed, fully operational, and effectively working (similar to home radon system)

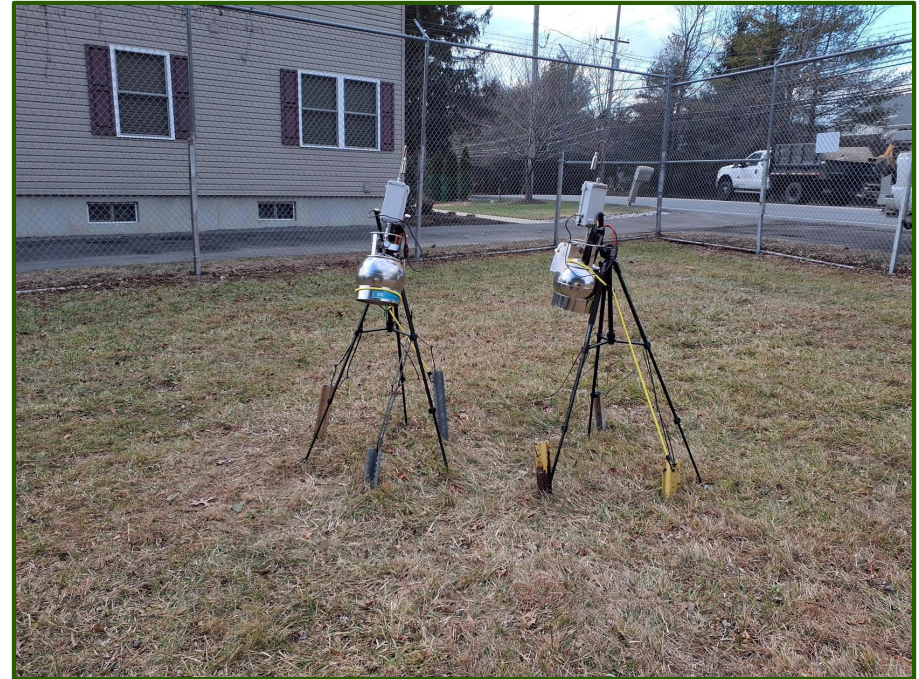
# Protecting Public Health – Air Monitoring

- Daily fenceline perimeter air monitoring has been taking place since December.
- Data is shared weekly with PA DEP and results demonstrate that there is no impact to ambient air quality in the community.

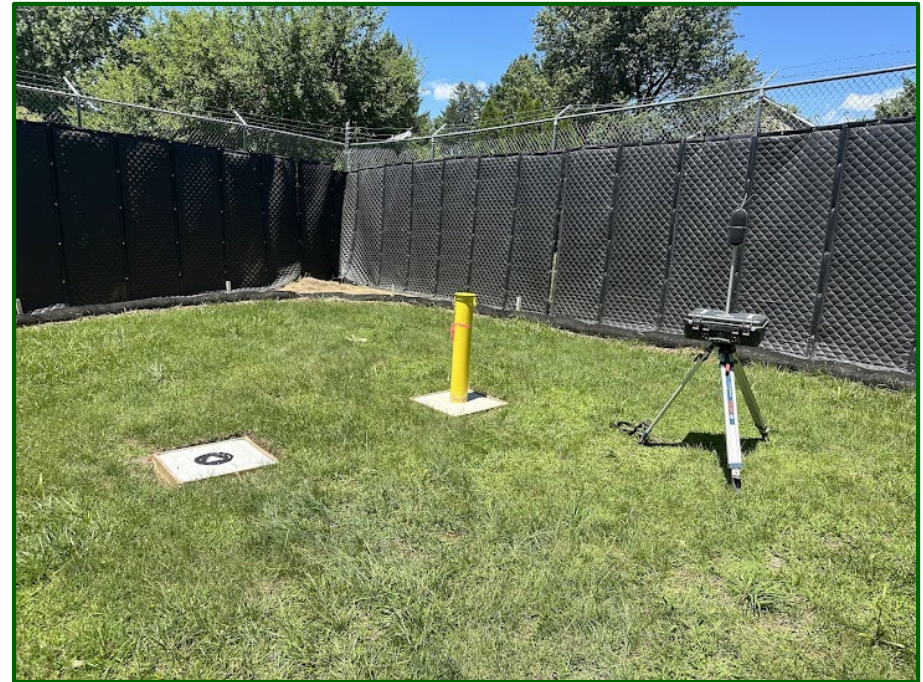
# Noise Mitigation

- Residents requested that we mitigate noise while drilling work occurred on site.
- Installed temporary sound dampening blankets to reduce noise that residents heard when and vacuum truck operations and drilling were taking place.

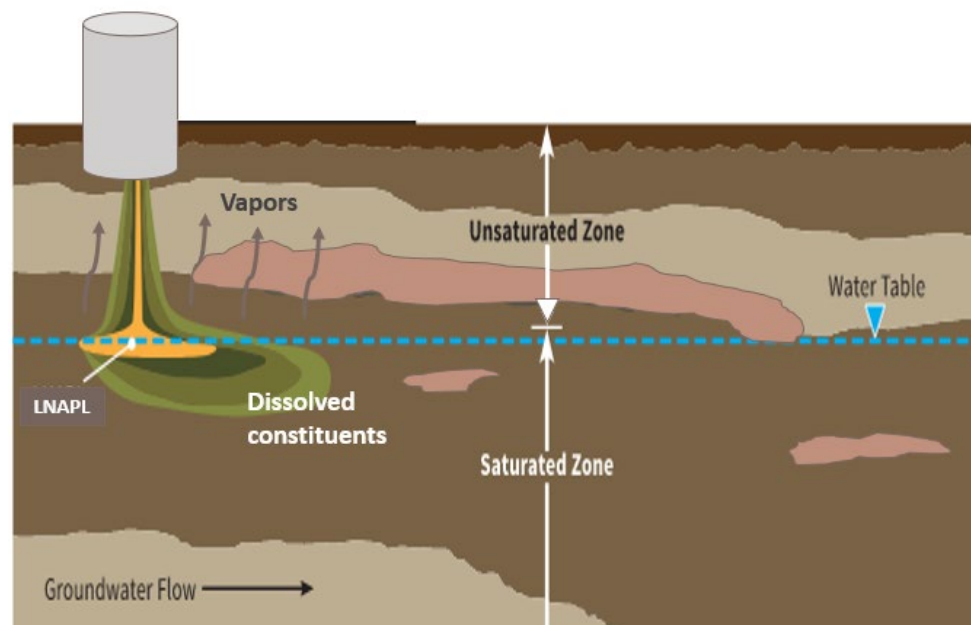
# Recovery & Remediation - Investigation

- Investigation efforts run in tandem with removal of gasoline, preventing potential human exposure and reducing risks.
- Gasoline is present in soil and shallow groundwater around the area of impact.

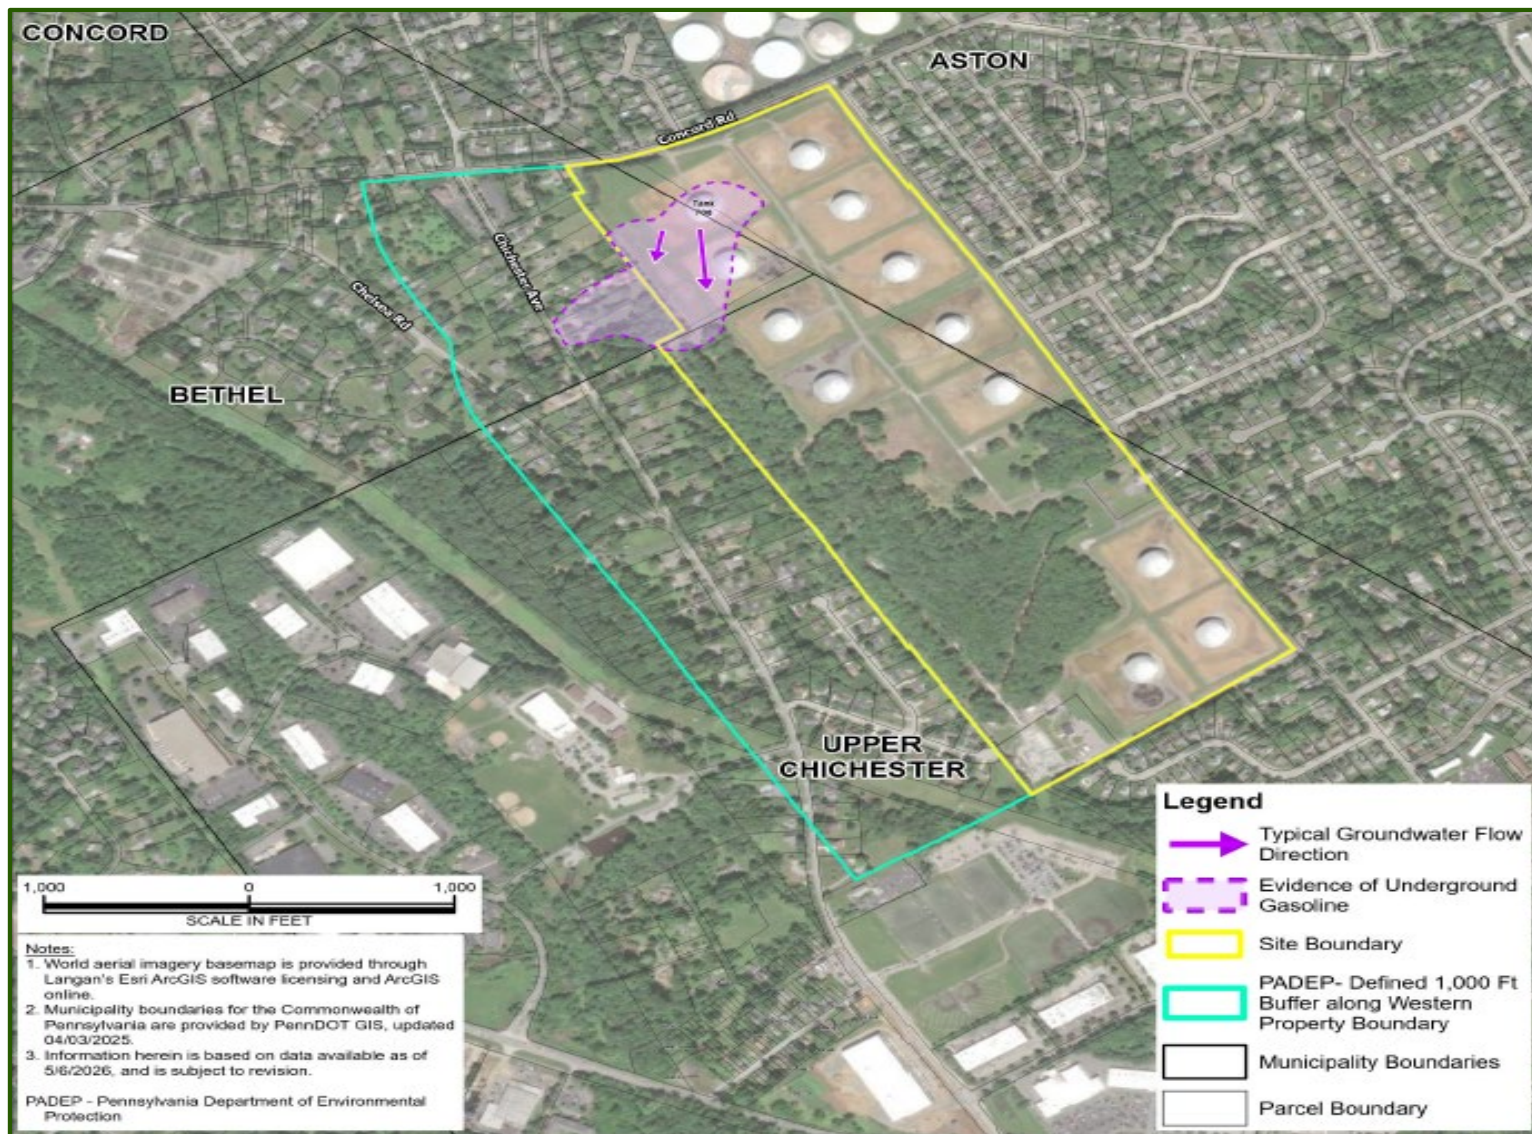
# Recovery & Remediation - Delineation

- What is our process to determine delineation?
  - 99 groundwater monitoring and recovery wells have been drilled on site.
  - 11 off-site groundwater monitoring wells that can readily be converted to recovery wells with additional wells planned as we work to complete delineation.
  - Establish a boundary around the area of impact to help us determine where gasoline is present versus where it is not.
